MALPORA LANDSLIDE STABILIZATION

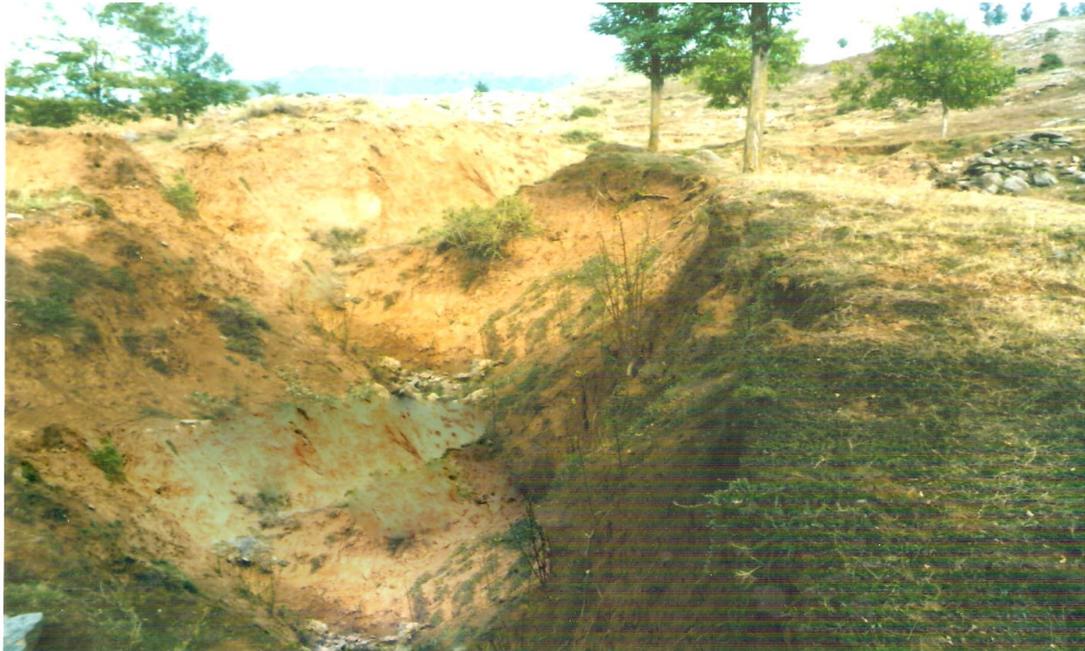
Malpora is located on Srinagar-Bandipora road near Ajas falling in micro watershed 0b1a in the district Bandipora. Initially a small drainage line that passed through this village over a period of years has developed into a deep ravine as a result of heavy soil erosion and sliding of slopes. It has threatened the life and property of the villagers and the surrounding area. The deposition of heavy load of silt and debris on the main road affects the connectivity also.

Gully formation before Treatment

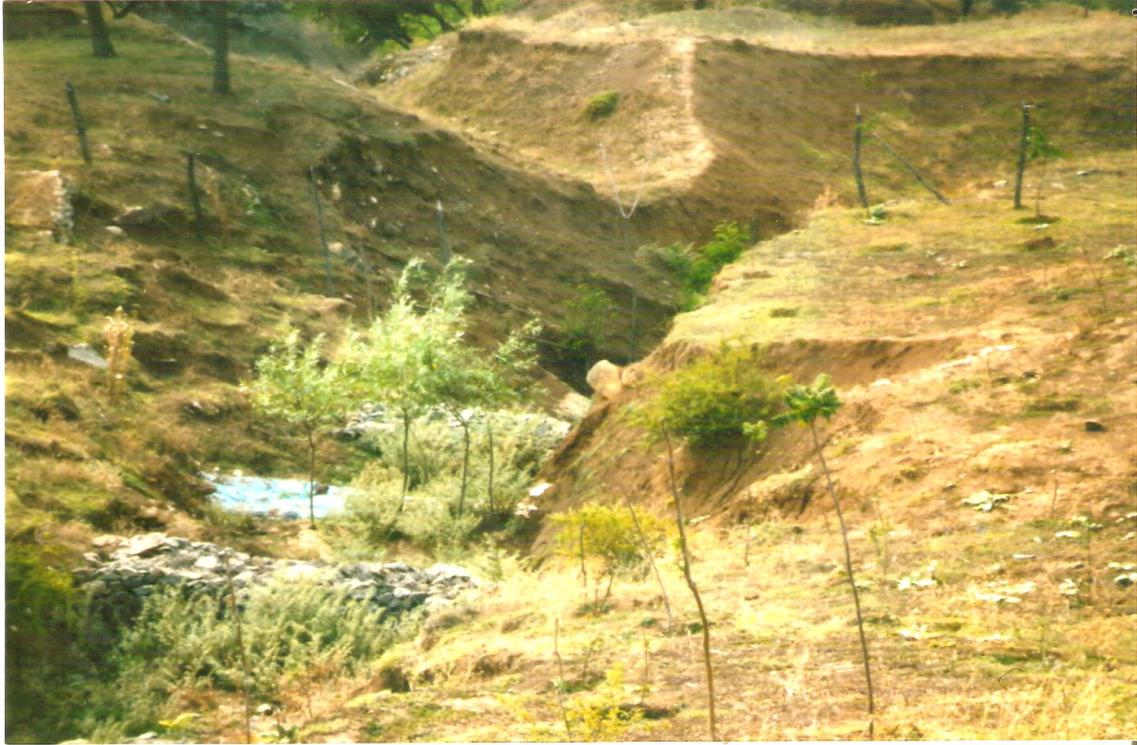
The area was identified and taken up by the Department of Soil Conservation in the year 2006-07 for treatment. Initially the soil conservation measures taken included gully control through stone/earthen bag check dams and plantation in the upper areas. Due to disturbance of hill sides by earth cutting for road and shacking effect of blasting at quarry sites which flank the area, the treatment needed modifications . Due to the disturbances coupled with weak geological formation the area has developed deep fissures and the slopes are sinking.

Gully plugging by vegetative and non-vegetative measures

In view of these challenges, sites specific measures were undertaken which have shown encouraging results. The structures were placed both at the top and at the toe end of the gully. In the later case the stone, crate and earthen bag check dams helped in stabilizing the structures as well as side slopes of the gully. During the period of last three years an area of 55 hectares has been brought under treatment with 22528 plants and non-vegetative gully plugging of 782 cum. The program for the area shall be continued for stabilization and reclamation through Mawa plantation, brush wood check dams , live hedge, grass sowing and wattling etc. with the model having combination of activities most suitable to the area.
